# Humber, Ford and Stoke Prior Bridleways

Annual Report - 2024

Iain Cholerton

1st May 2024

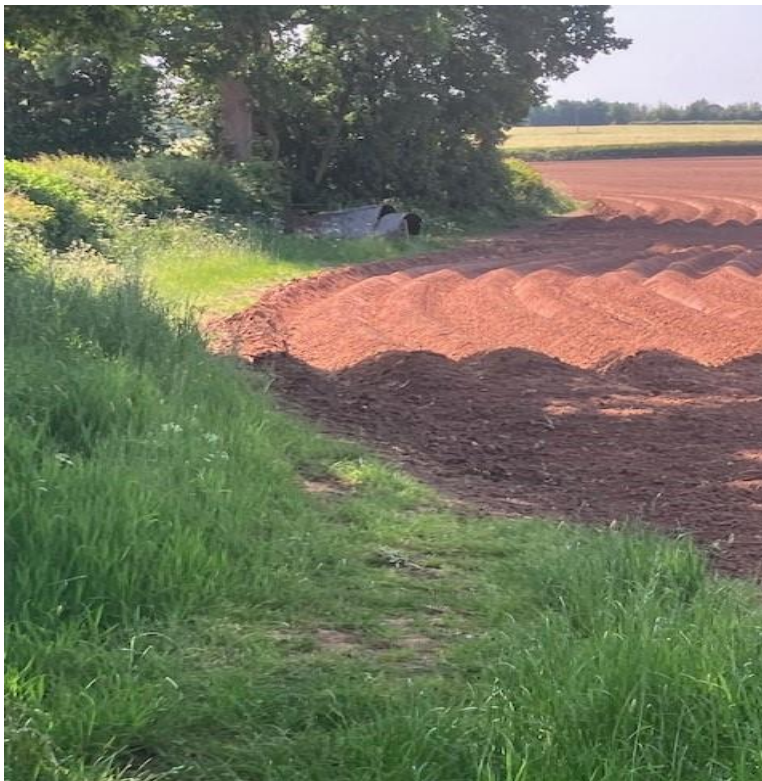
Photo 1. SP 28.1-2 (June 2023)

Issues remain with gates SP 28.1, SP 28.2, SP 28.3 and SP 28.4 as reported for a number of years. In addition, last summer the field between Wickton Lane and the Witsetts (Ken Bemand's) was ploughed for potatoes far too close to the PROW (Photo 1) forcing riders to pass dangerously close to a derelict metal shed. Horses often shy at this shed. Ideally it should be removed, and the required headland left each year for the PROW.

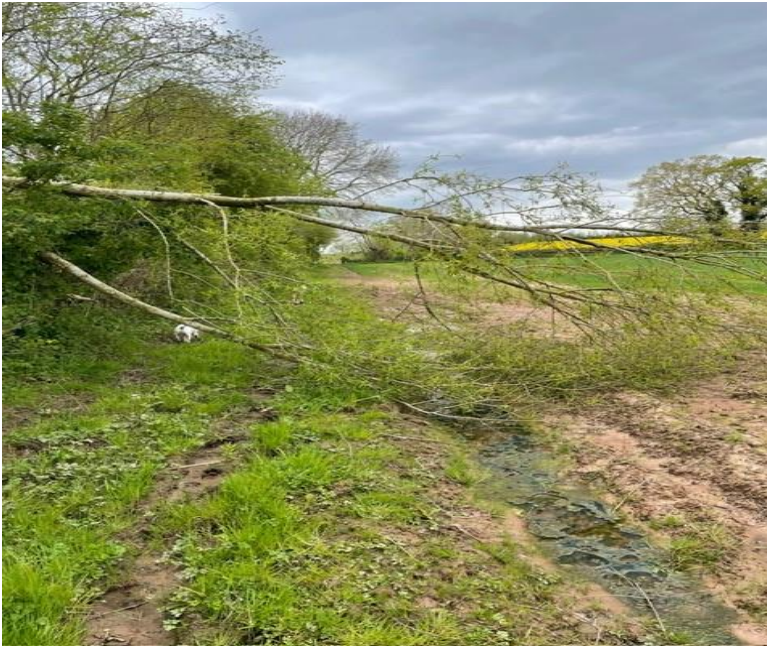
Photo 2. SP 28.1-2. (April 2024)

There is now a tree down across the route between SP 28.1 and SP 28.2. I would be grateful if the lengthsman could be tasked to clear it. (Photo 2)

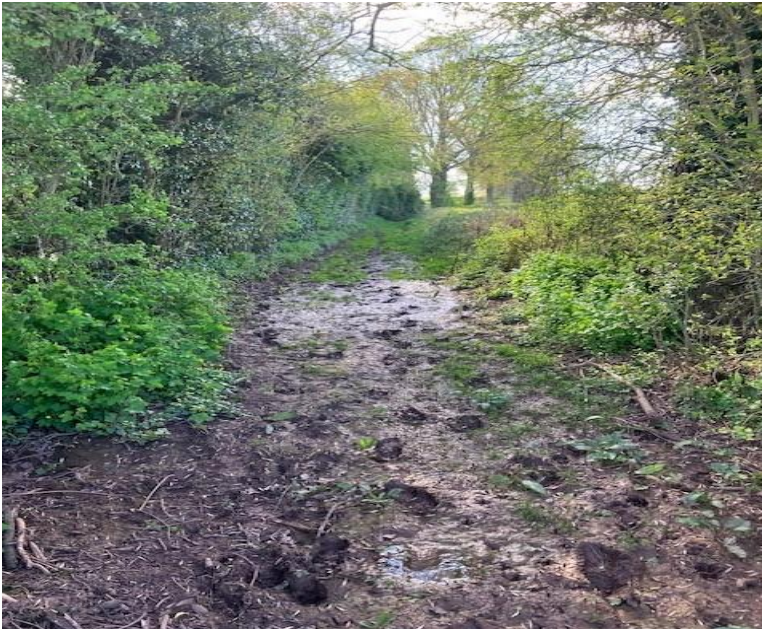
Photo 3. SP 28.1 to the road (April 2024)

The route as it approaches the road at the Witsetts from SP 28.1 has been swamped for much of the winter and was largely unusable. Photo 3.

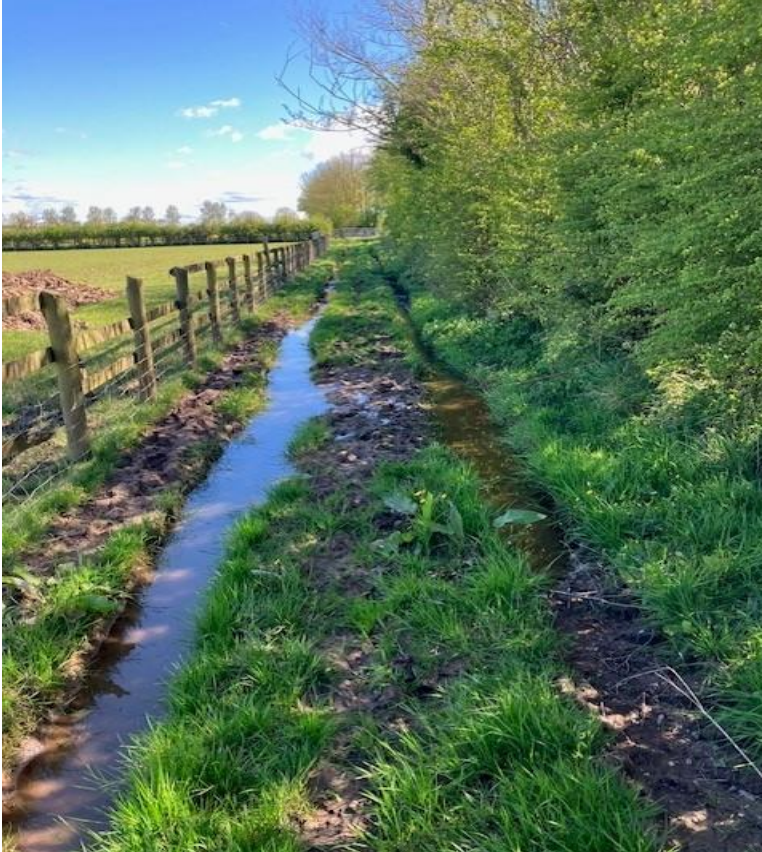
Photo 4. SP 12.2 – SP 12.3 (April 2024)

No significant changes. As in previous years the track from SP 12.2 to SP 12.3 has again been deeply rutted by farm traffic making it difficult to use in the winter months. (Photo 4)

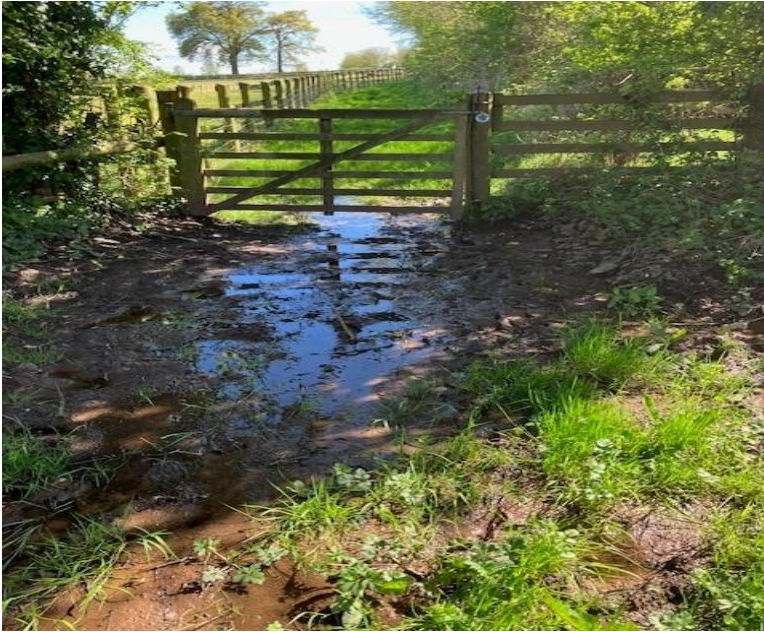
Photo 5. SP 12.3 (April 2024)

Similarly, the gate SP 12.3 remains very difficult to use during wet periods. (Photo 5)

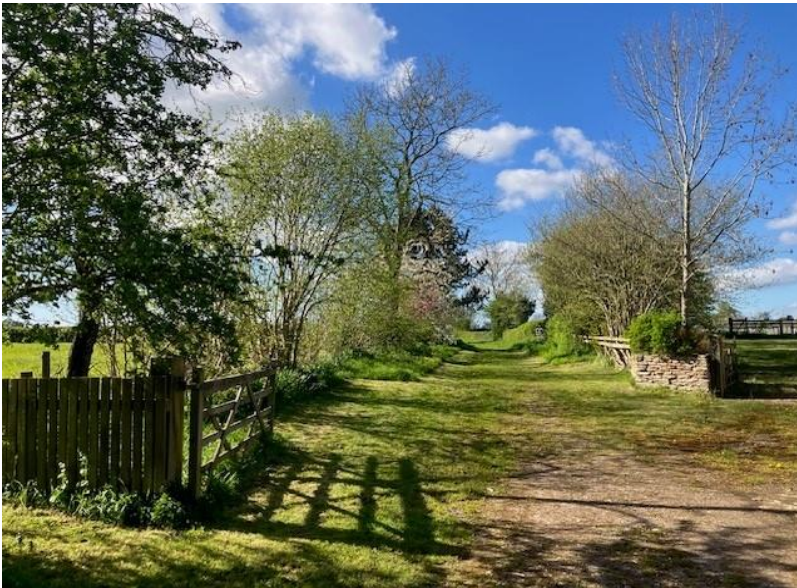
Photo 6. SP 17 (April 2024)

Nothing significant to report. All well-maintained by Pete L-H. Many thanks.

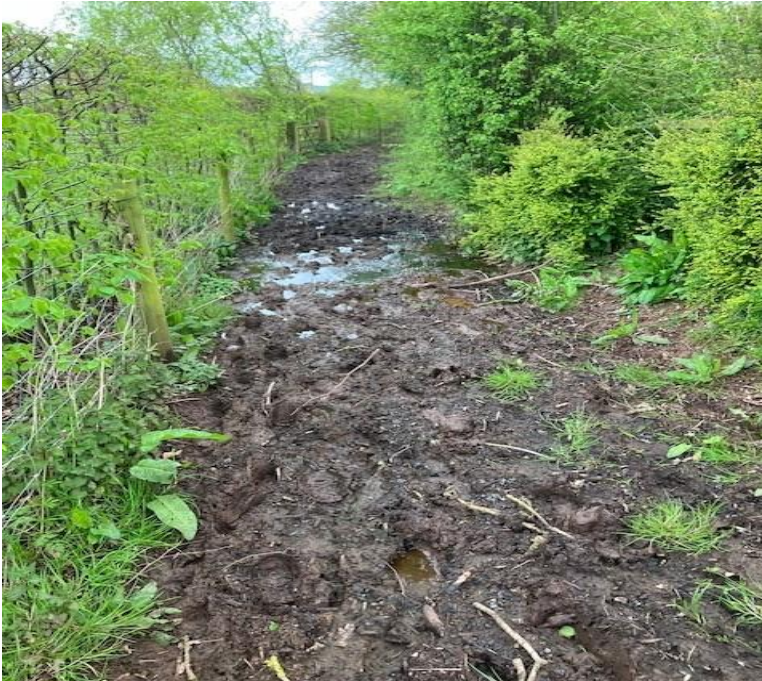
Photo 7. HU 10.2-3 (April 2024)

The very wet winter and spring has again made this route difficult between HU 10.2 and HU 10.3 (Photo 7).

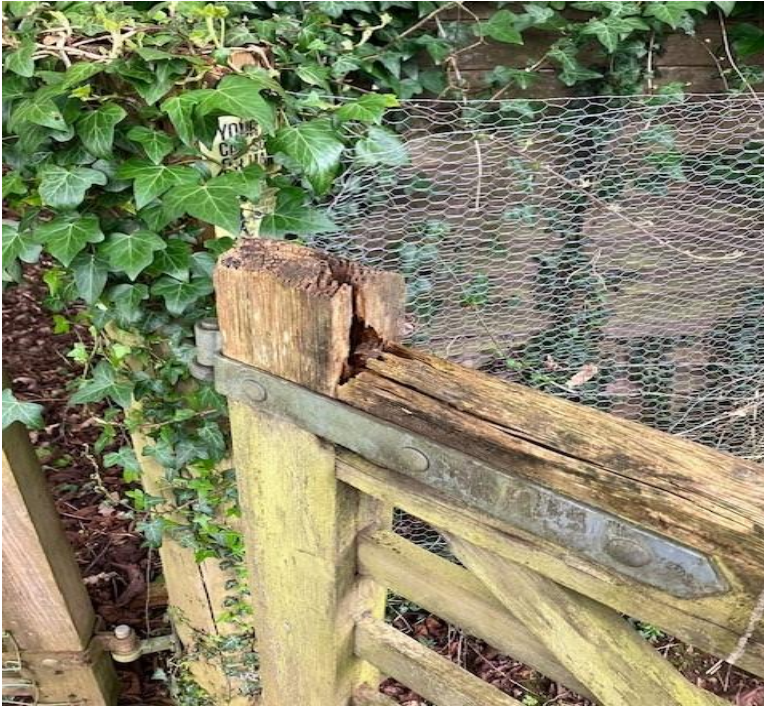
Photo 8. HU 10.3 (April 2024)

HU 10.3 has deteriorated further this year. The gate is rotten (Photo 8) as is the post at the base which now moves when the gate swings open. It is in need of replacement. (Photo 9).

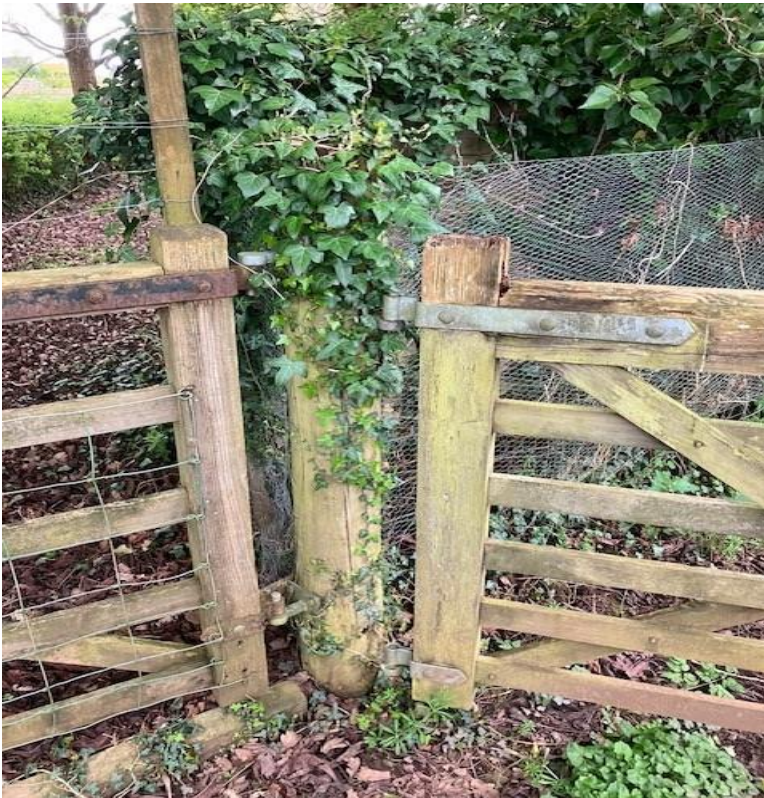
Photo 9. HU 10.3 (April 2024). Wobbly post.

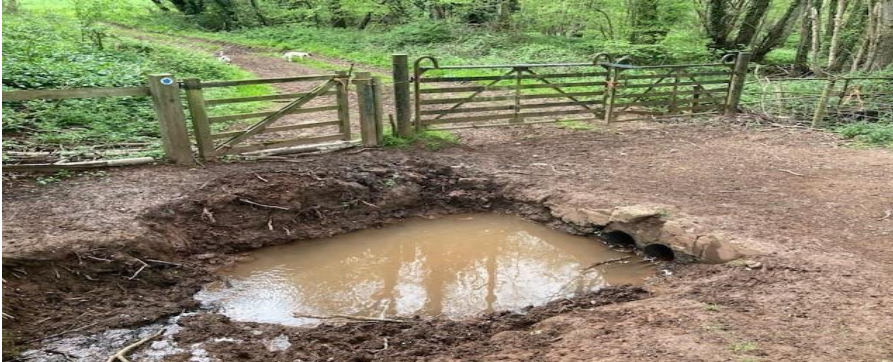
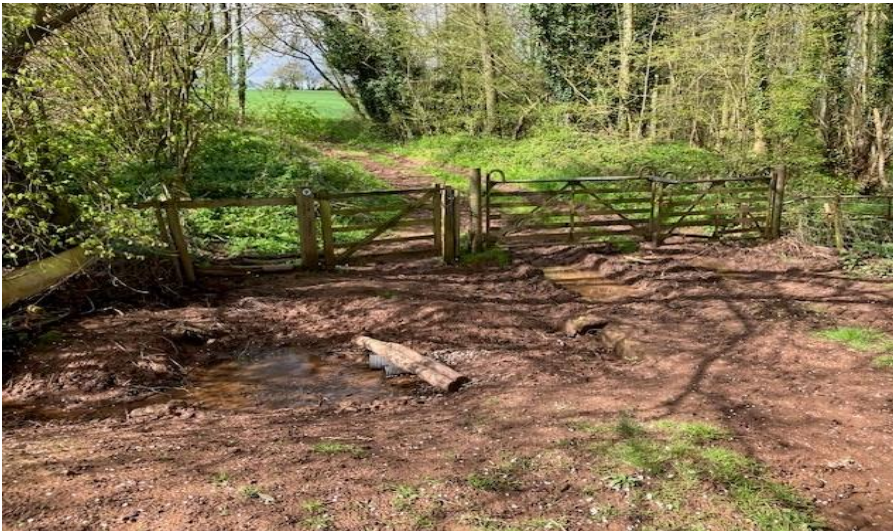
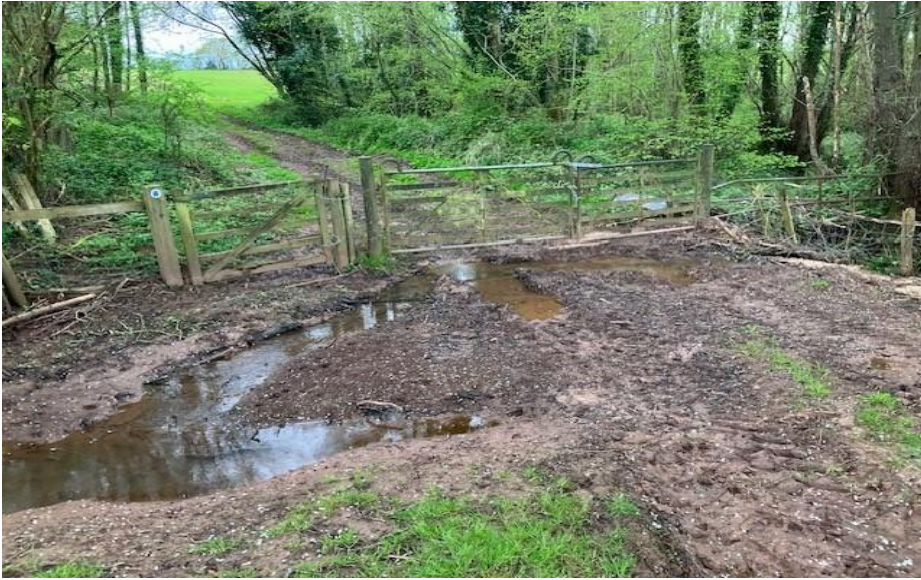
The courts judged that the PROW did indeed pass through the large double gates at PG 11.2 and these can now be opened from the mounted position. Regrettably it is still chained (see Photo 13). The small gate has been secured by wire and is no longer used. The large open ditch has now been filled and the stream passes through and over the bridge – not ideal but a good deal safer than previously now that the double gates are used. (Photos 10,11,12). So NFA required.

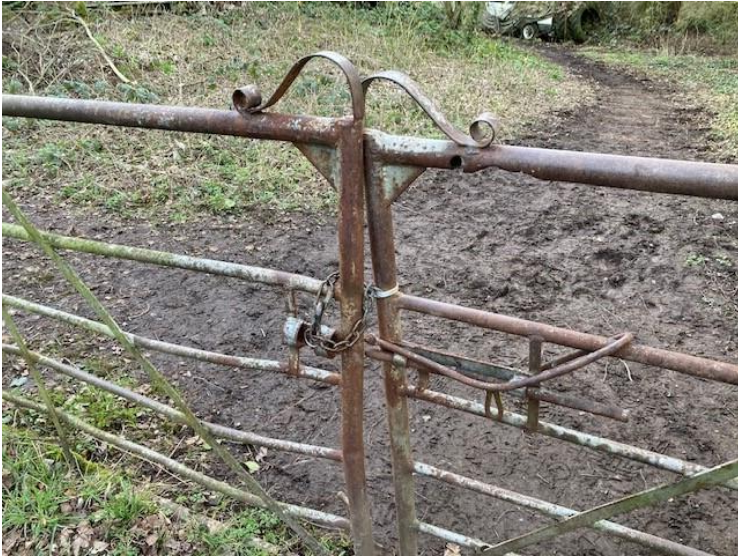
Photo 14. PG 11.6 (March 2021)

The gate at PG 11.6 (Photo 13) is still chained and requires a dismount and two hands to open and close.

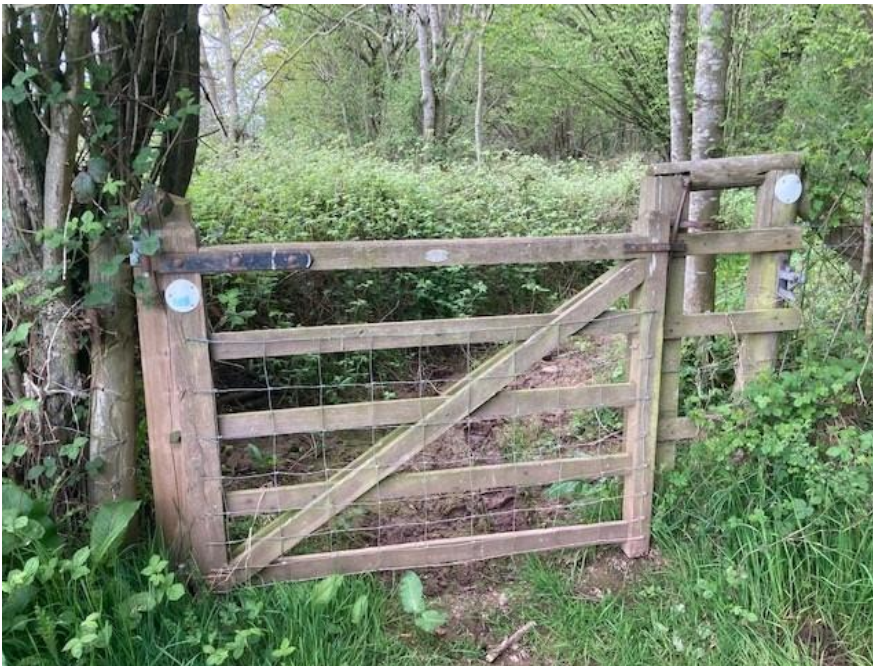
Photo 15. PG 11.11 (May 2022)

The route exits the wood through PG 11.11 and continues to Hegdon Hill outside the Parish Boundary. The gate was replaced in 2022 (Photo 15) and the drainage seemed much improved that year, but it is now flooded again and there is little rider traffic as a result. (Photo 16).
